[Docket No. 2001-SW-40-AD; Amendment 39-13022; AD 2002-13-05 R1]

Airworthiness Directives; MD Helicopters, Inc. Model 369D, 369E, 369F, and 369FF Helicopters

2002-13-05 R1 MD Helicopters, Inc.: Amendment 39-13022, Docket No. 2001-SW-40-AD.
Revises AD 2002-13-05, Amendment 39-12793.

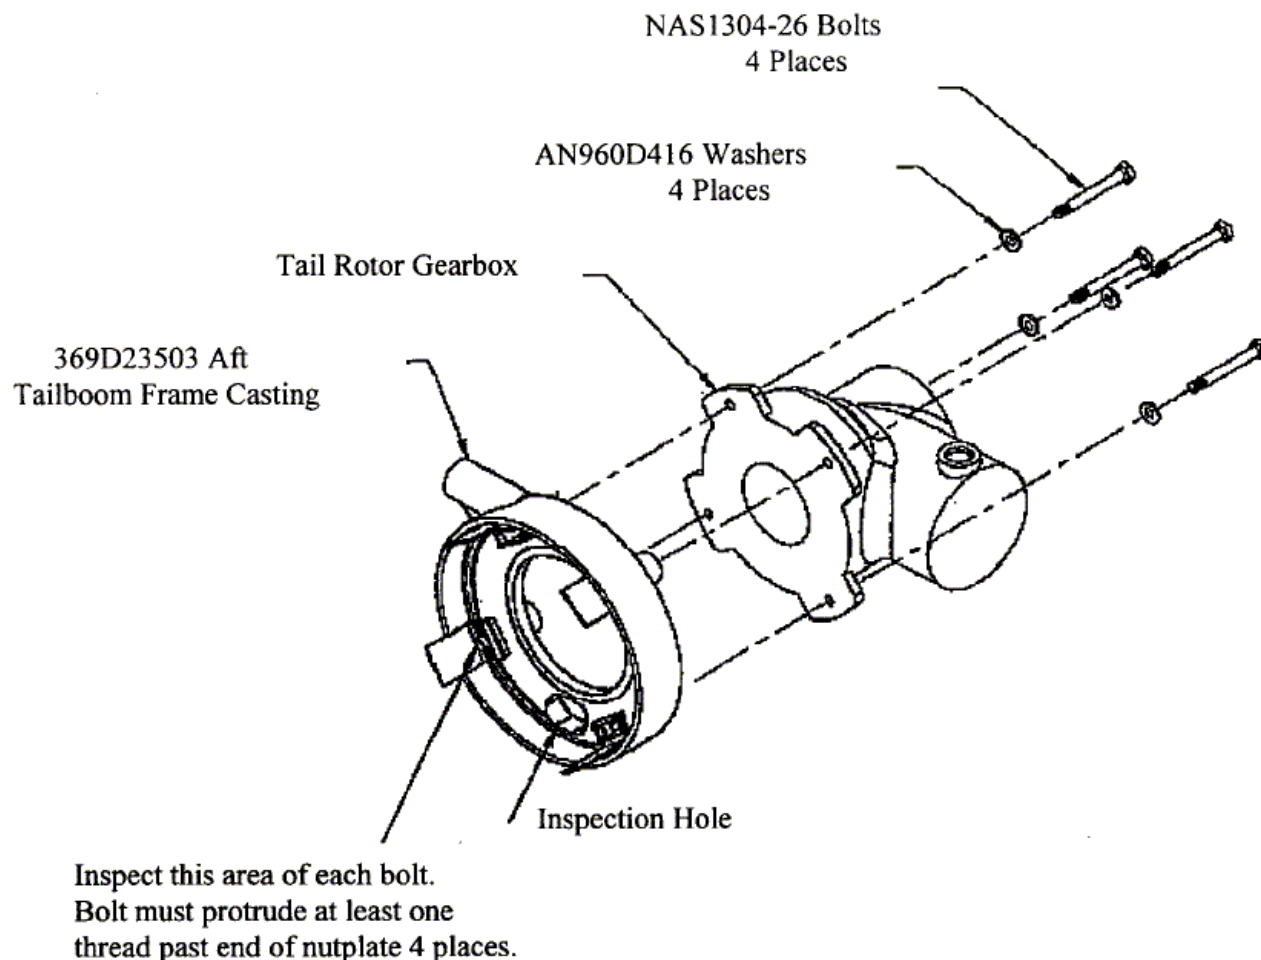
Figure 1 - Inspection Location

To prevent loss of the tail rotor gearbox due to attaching bolts of inadequate grip length and subsequent loss of control of the helicopter, accomplish the following:

- (a) Within 25 hours time-in-service (TIS):
 - (1) For each tail rotor gearbox attaching bolt (bolt):
 - (i) Determine the part number (P/N).
 - (ii) If the P/N cannot be determined or if the bolt is not P/N NAS1304-26, before further flight, replace the bolt with bolt, P/N NAS1304-26.
 - (iii) Torque the bolt to 100-110 in-lbs and apply a slippage mark.
 - (2) Remove the tailboom control rod and determine the number of bolt threads protruding from each nutplate on the internal surface of the aft tailboom frame casting, P/N 369D23503, as shown in Figure 1 of this AD. At least one thread must protrude. If more than four threads protrude, add an additional washer, P/N AN960D416, under the bolt head. Torque the bolt to 100-110 in-lbs, and reapply a slippage mark. See Figure 1:

(b) Between 2 and 10 hours TIS after accomplishing the requirements of paragraph (a) of this AD, inspect the torque on each bolt by applying 100 in-lbs. If any bolt movement occurs, retorquing the bolt to 100-110 in-lbs. Reapply a slippage mark to the bolt regardless of the outcome of the torque test. Reinspect the torque between 2 and 10 hours TIS thereafter until no bolt movement occurs.
